NATIONAL DAM SAFETY PROGRAM. HUNTING CAMP DAM (INVENTORY NUMBER--ETC(U)

Name Of Dam: HUNTING CAMP DAM
Location: BLAND COUNTY, VIRGINIA
Inventory Number: VA. NO. 02101

LEVEL
PHASE I INSPECTION REPORT
NATIONAL DAM SAFETY PROGRAM

BY
SCHNABEL ENGINEERING ASSOCIATES, P.C./
J. K. TIMMONS AND ASSOCIATES, INC.

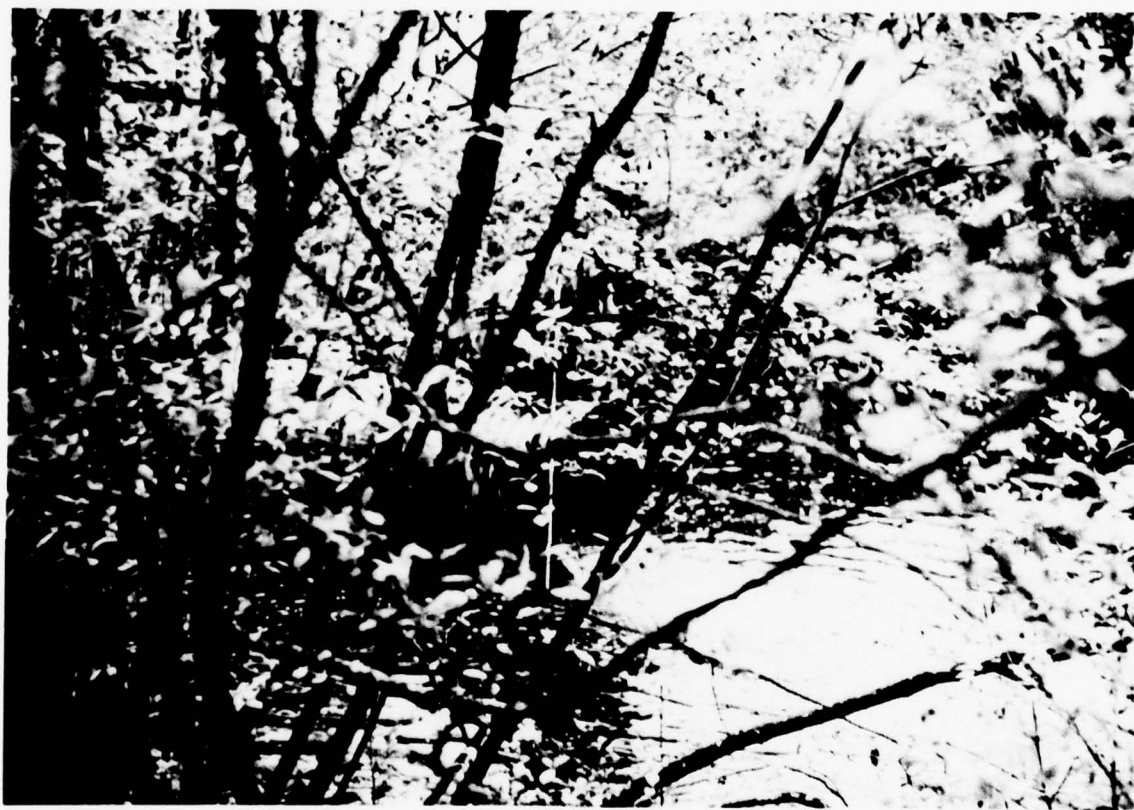
CLOSE-UP OF OUTLET PIPE

2.1 Outlet Conduit: 30 inch CMP. Some corrosion but not significant.

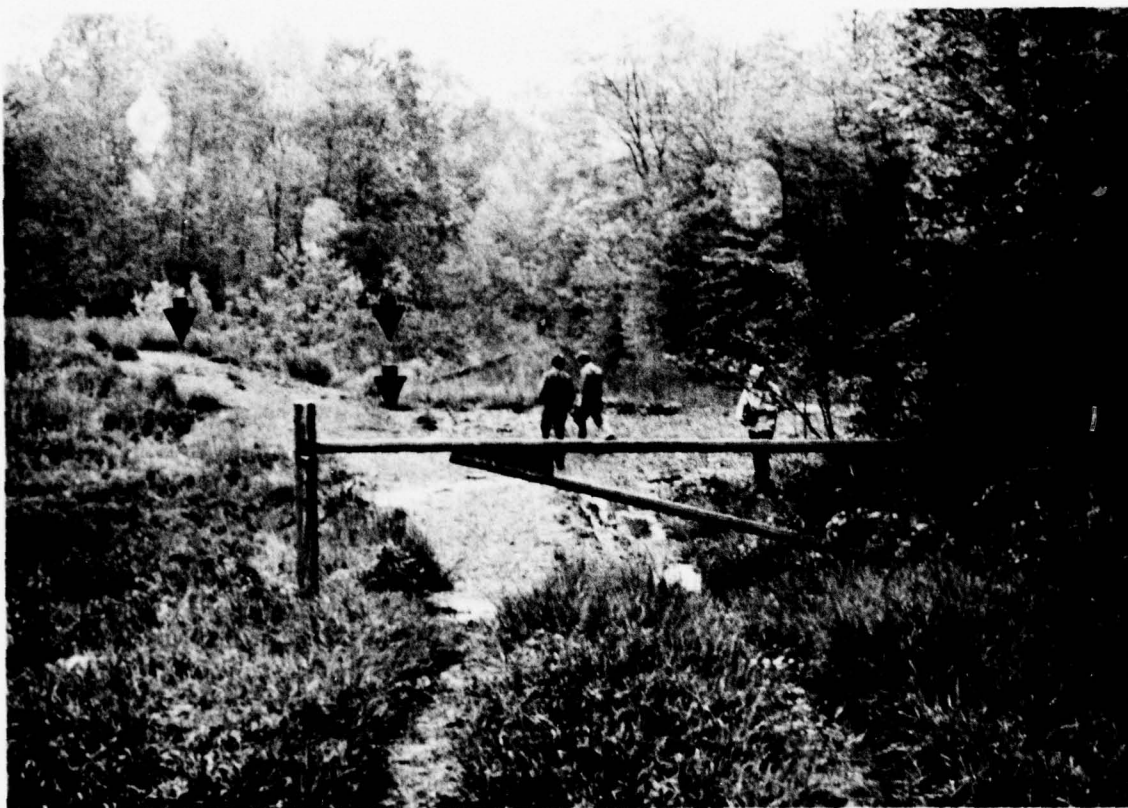
There are two trapezoidal channels; one located on each abutment, used for emergency spillways. They both empty into broad wooded floodplain-type areas. Erosion had occurred in 1977 to the right spillway, but has since been repaired and stabilized.

SPILLWAY IN RIGHT ABUTMENT
(Outlined with Arrows)

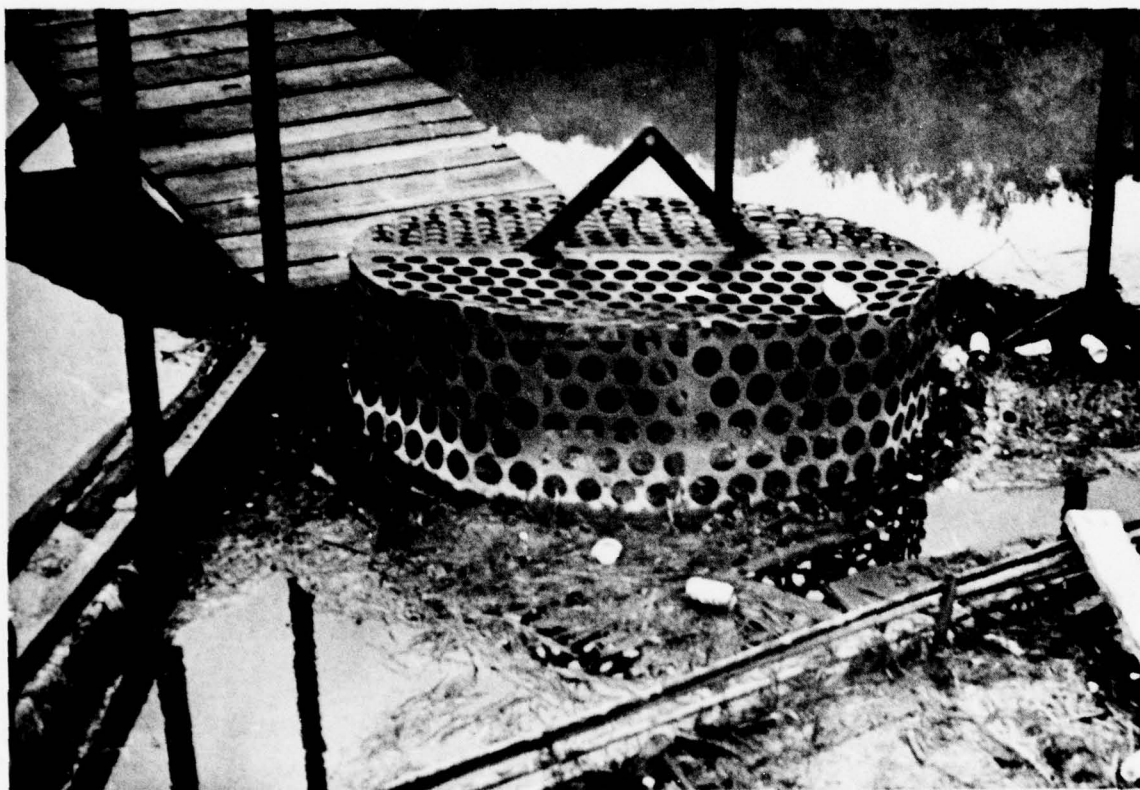
The principal spillway has a 42 inch CMP riser with a 30 inch CMP outlet pipe. The intake is in good condition. No spalling or cracking was observed. A small amount of debris was noted in the trash rack. The 12 inch gate is reportedly operational.

CLOSE-UP DEBRIS RACK AT 42" INTAKE

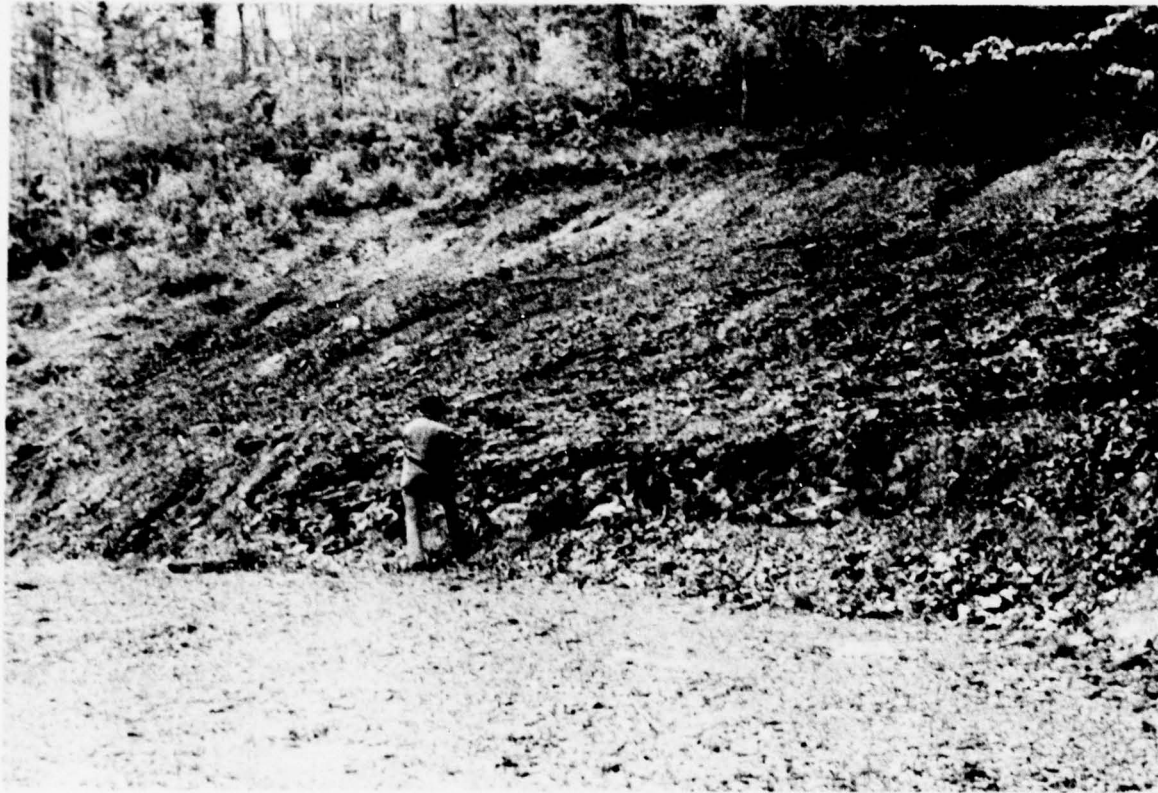
VIEW OF BORROW AREA FOR REPAIR OF SPILLWAY

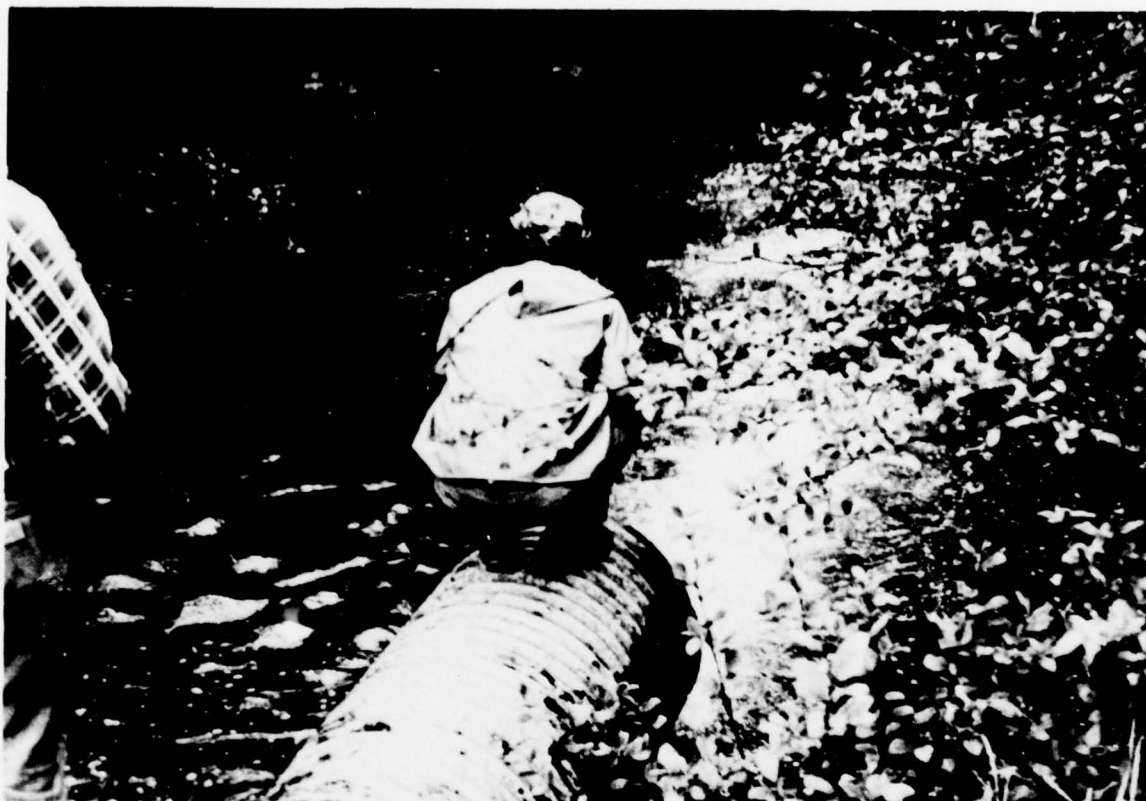
VIEW OF OUTLET STRUCTURE LOOKING DOWNSTREAM

2.3 Outlet Structure: In good condition.

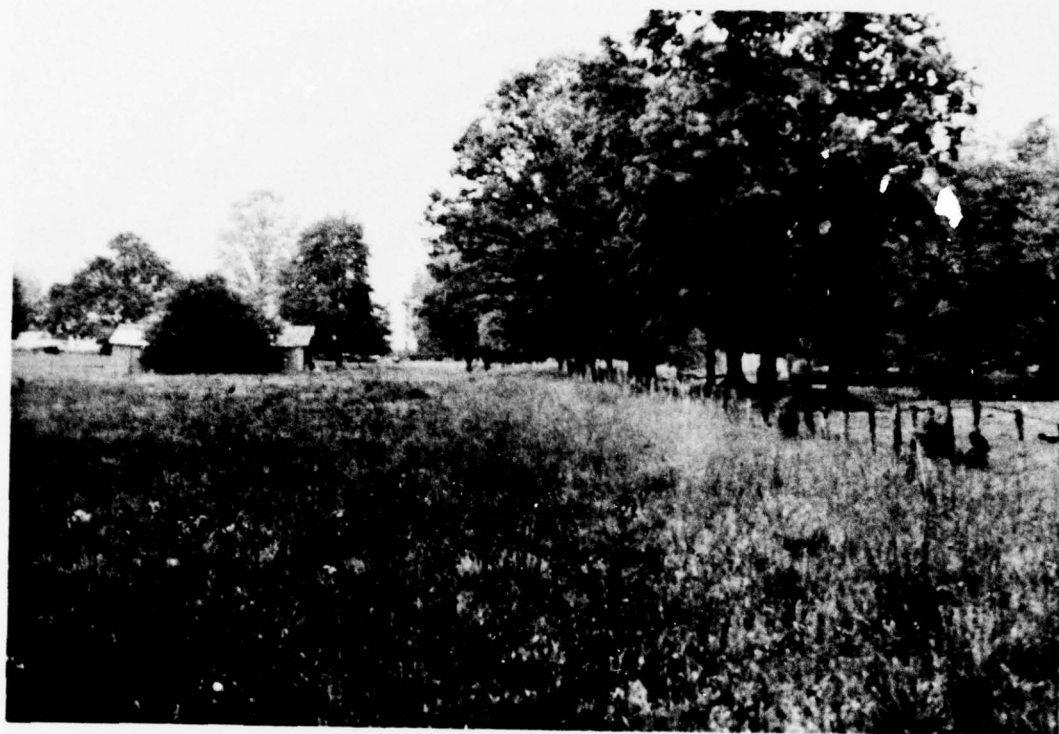
VIEW OF DOWNSTREAM FLOODPLAIN

2.4 Outlet Channel: Broad, wooded floodplain. No riprap and minor erosion observed.
